WT-1181

Operation TEAPOT

Projects 36.1 and 36.2

EXPOSURE OF MOBILE HOMES AND EMERGENCY
VEHICLES TO NUCLEAR EXPLOSIONS

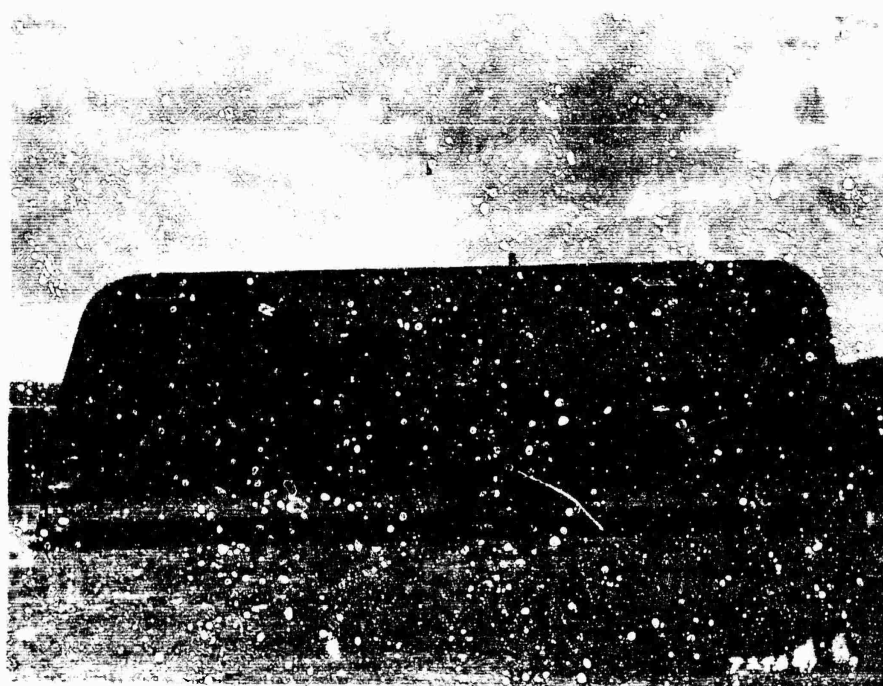
Exterior: Slight distortion on left side. (See Fig. 2.13.)

Fig. 2.13—Exterior of Columbia trailer at 15,000 ft after the blast.

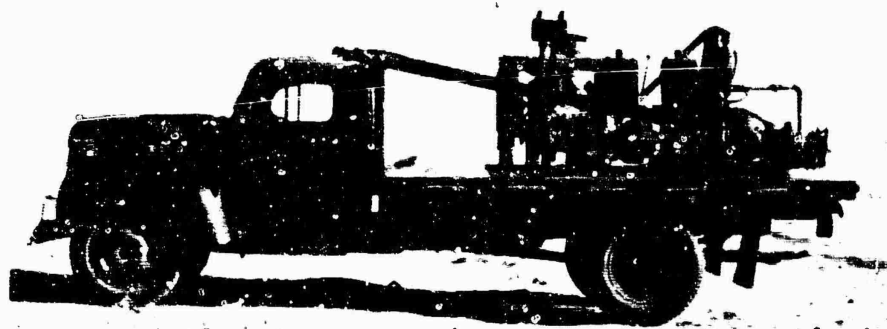
Test Results: This truck was overturned. The roof of the cab was dished in, and the door on the side of the truck facing the blast was badly damaged. The earth-boring machine was knocked loose from the truck and was on its side. Later this truck was pulled into an upright position and driven from its location. Operating condition of the earth-boring machine was not determined. (See Fig. 3.6.)

Fig. 3.5—Truck with earth-boring machine at 4700 ft before the blast.

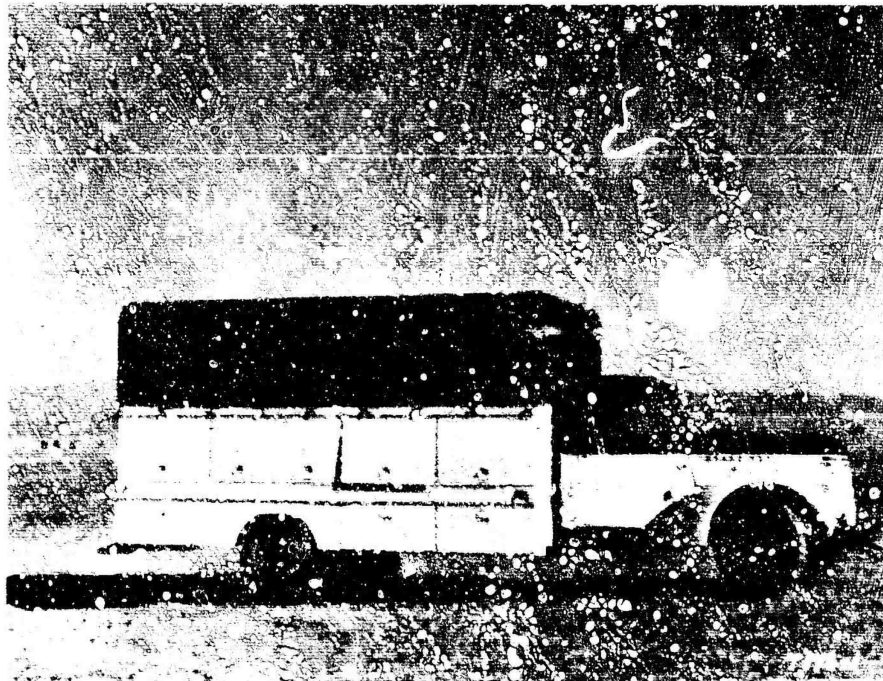
Test Results: Only one wheel and part of an axle were found after the blast. (See Fig. 3.17.)

Fig. 3.16—Rescue truck at 1470 ft before the blast.

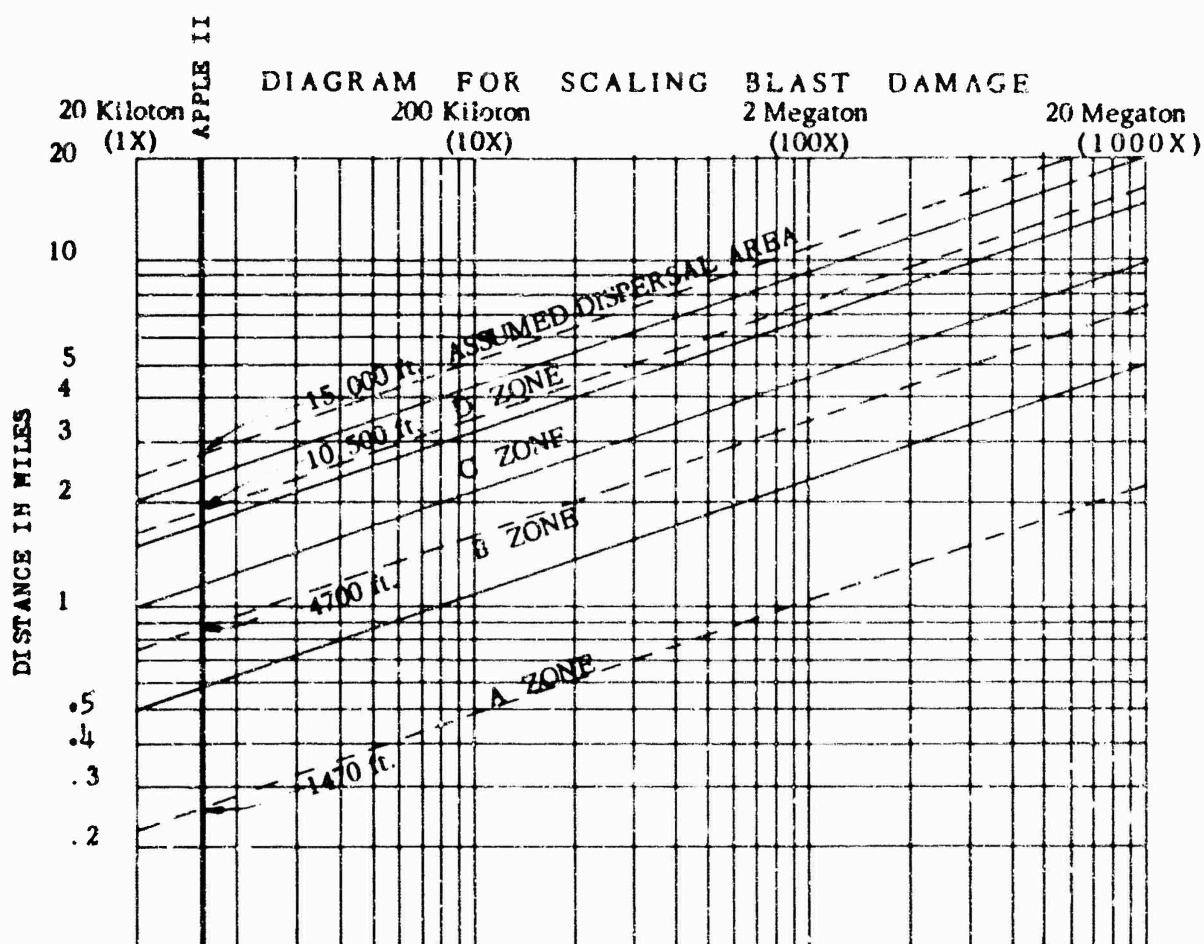
The test results of Program 36 demonstrate the effects of a nuclear explosion of a particular yield on trailer coaches and emergency vehicles located at particular distances from Ground Zero of a shot with a yield approximately 50 per cent greater than nominal. Through the use of scaling laws published in "The Effects of Atomic Weapons" and presented in graphic form in Fig. 4.1, these results can be applied to different-size bombs and different distances

Fig. 4.1 — Range of damage as a function of bomb yield.

Chicago has an area of 207.5 square miles. This area would be included in a circle of 8.1 miles radius. By assuming that a bomb used on Chicago would cause C damage to 8.1 miles from Ground Zero, the bomb size from the curve of Fig. 4.1 is seen to be approximately 3.1 megatons (Mt). Under this condition the damage occurring at the various distances from Ground Zero in Apple II shot would occur as shown in Table 4.1. By this procedure the comparable-
